Strategies^{for} High Performance Renovation^{on a} Budget

Affordable Energy-Efficiency in an Existing Facility

Case Study 1: Foster Heights Elementary

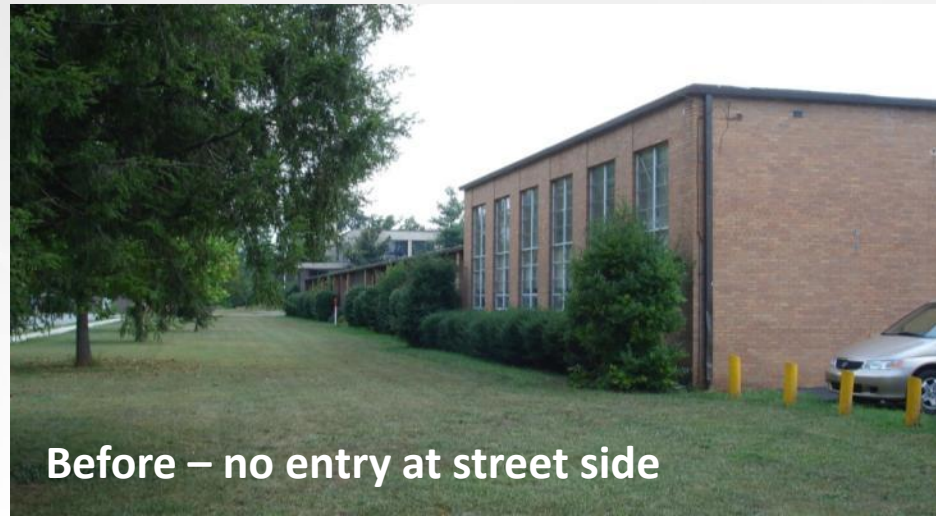
Before – no entry at street side

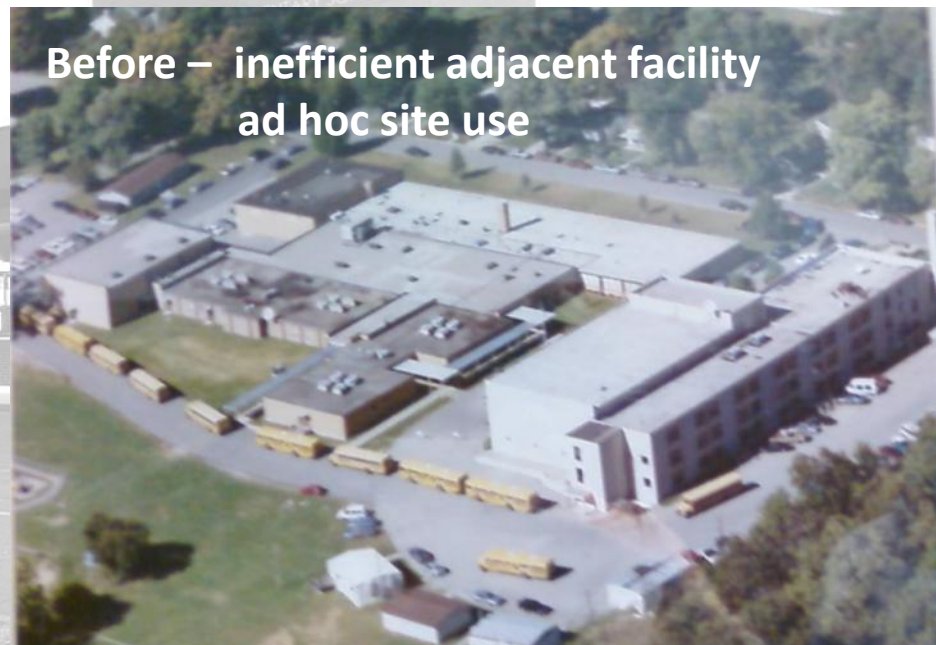
Before – inefficient adjacent facility
ad hoc site use

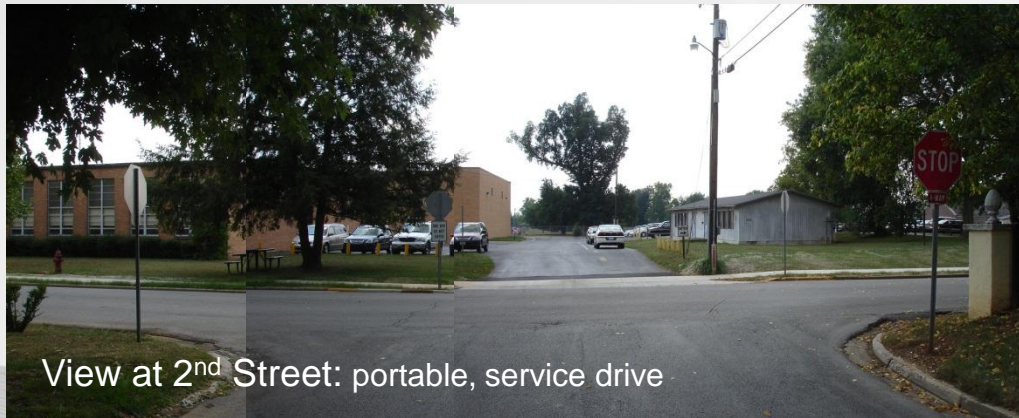
View at 2nd Street: portable, service drive

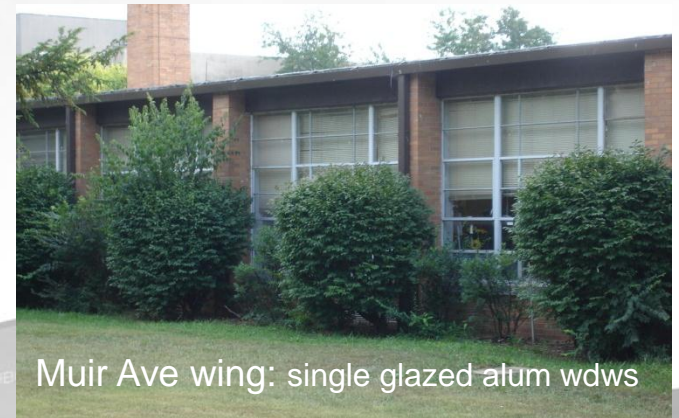
Muir Ave wing: single glazed alum wdws

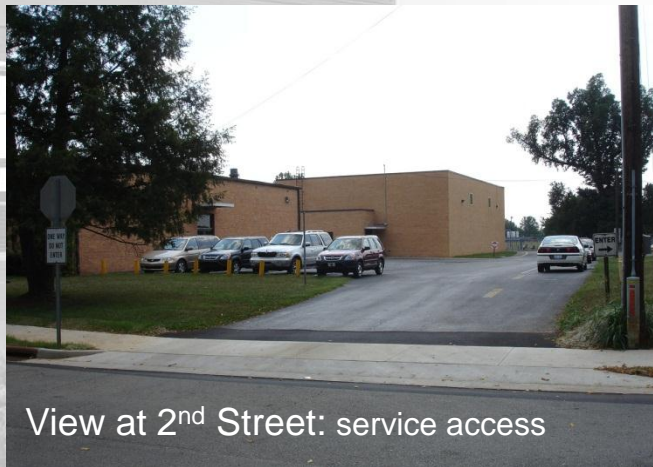
View at 2nd Street: service access

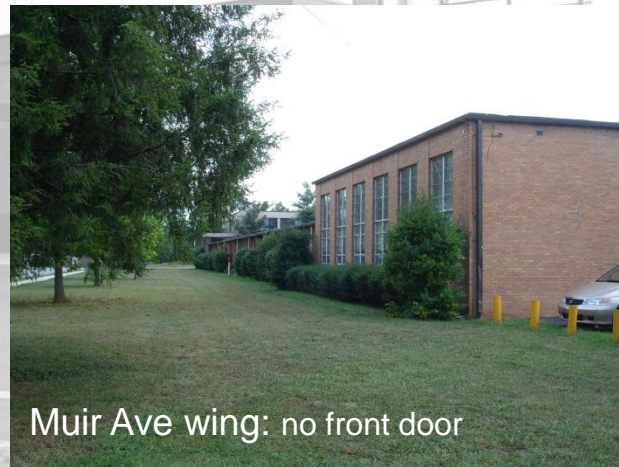
Muir Ave wing: no front door

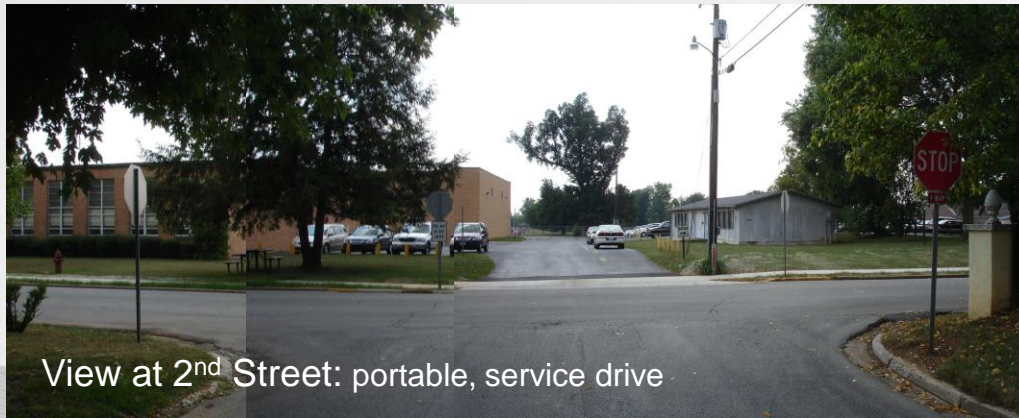
View at 2nd Street: portable, service drive

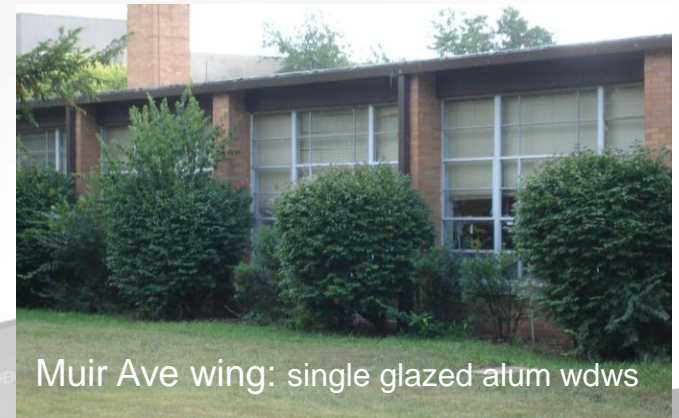
Muir Ave wing: single glazed alum wdws

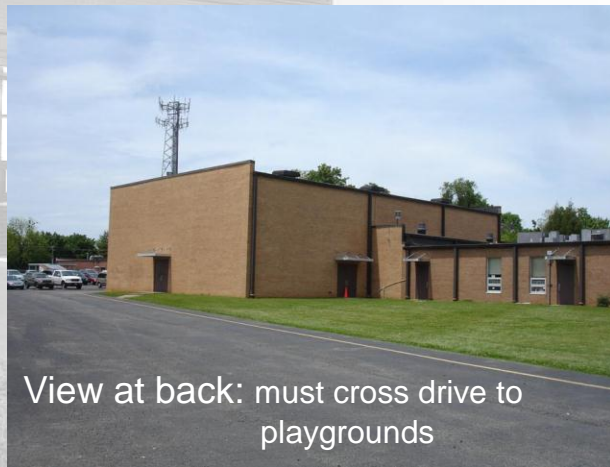
View at back: must cross drive to playgrounds

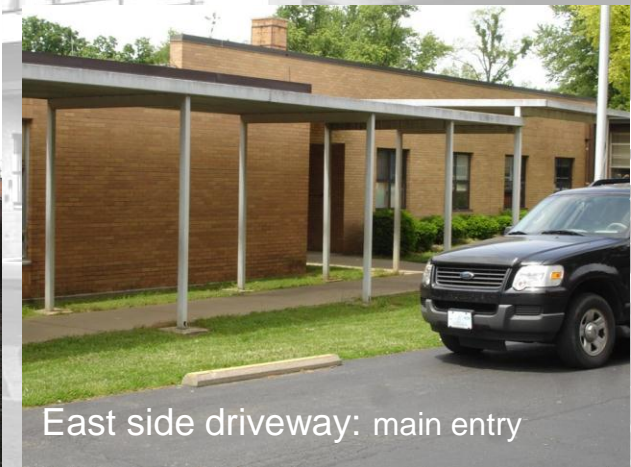
East side driveway: main entry

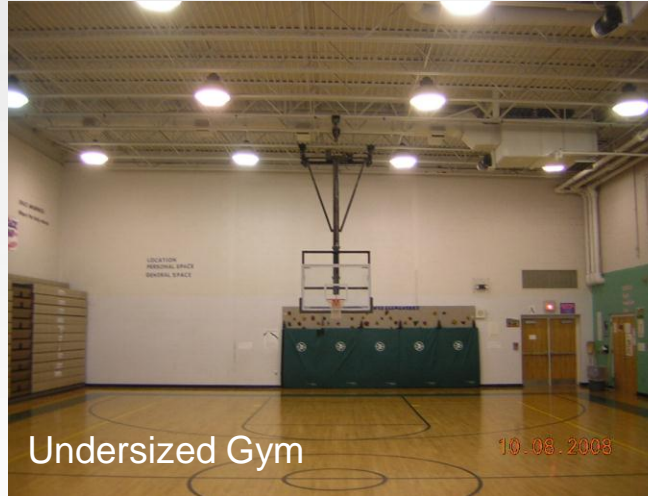
Undersized Gym

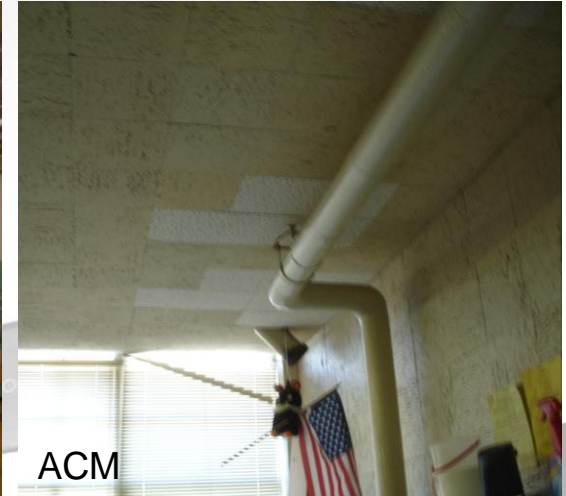
ACM

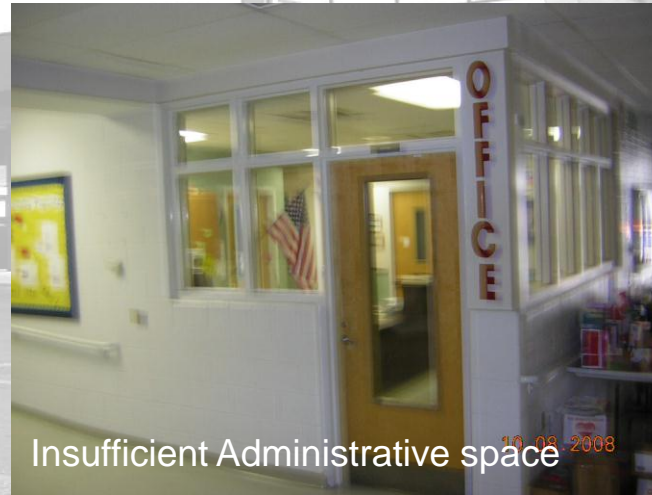
Insufficient Administrative space

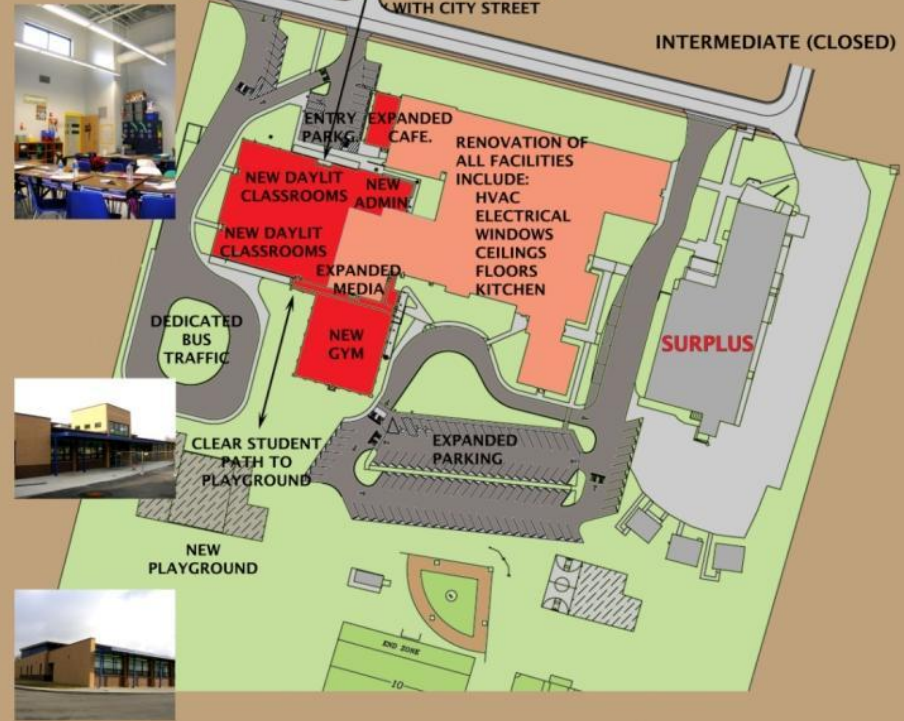
NOW: 1 CONSOLIDATED FACILITY

ELEMENTARY 1-5
SINGLE FACILITY ACCOMODATES
1 THROUGH 5
ELIMINATES SECOND SCHOOL BLDG
& REDUNDANT ADMINISTRATION
FULLY RENOVATED + EXPANDED
FACILITIES
DEDICATED BUS TRAFFIC, PARKING
& DROPOFF FOR SAFETY

NEW ENTRY ALIGNED
WITH CITY STREET

INTERMEDIATE (CLOSED)
